Manhole Inspection Summary

Manhole # S33Q__012MH

Insp Date: **3/14/08 8:49 AM**

Location Address: **1100 leadenhall**

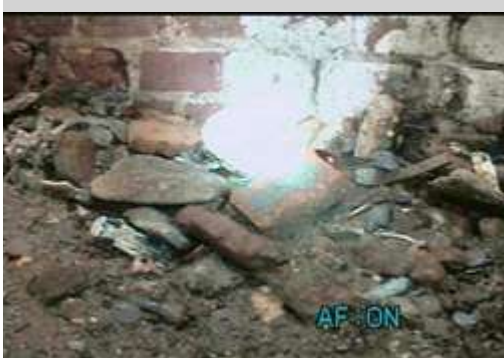
Condition: ☒ Sound ☐ Cracked ☐ Root Intrusion ☐ Deteriorated ☐ Leaks ☐ Debris

bench debris

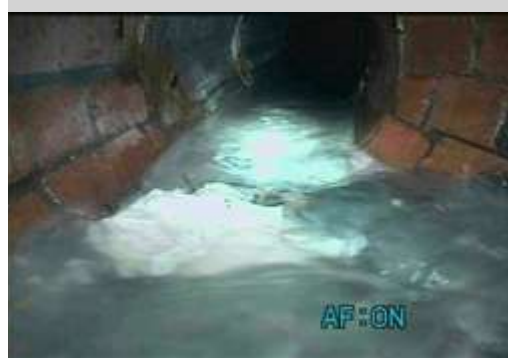
Defect 5

Condition: ☐ Sound ☐ Cracked ☐ Root Intrusion ☐ Deteriorated ☐ Leaks ☒ **Debris**

channel debris

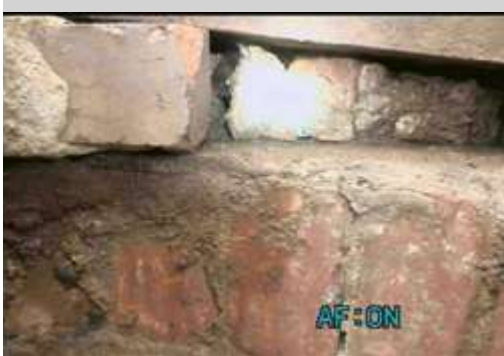
Defect 3

Condition: ☐ Sound ☐ Cracked ☐ Root Intrusion ☒ **Loose Brick** ☐ Deteriorated

Chimney_Loose bricks

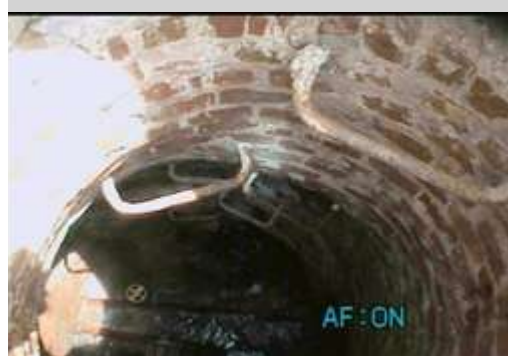
Defect 2

Count: **6** Missing: **0** ☒ **Corroded**

corroded steps

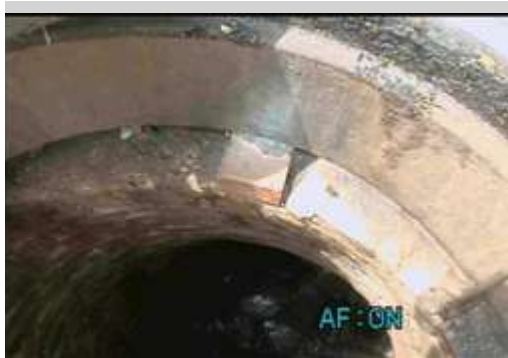
Defect 1

Offset: **2** (in.)

offset

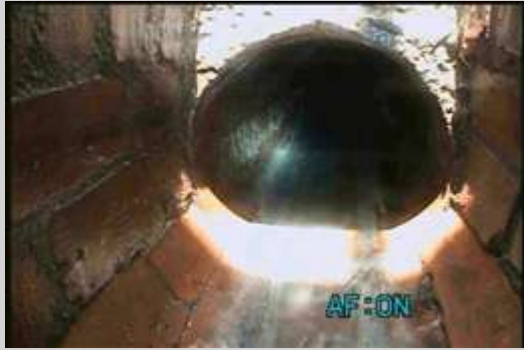
6 O'Clock Inflow

Deposits: ☐ None ☐ Mud ☐ Sludge ☒ **Debris** ☐ Grease

Silt Depth: **3** (in.) Deposits Extent: **Medium**
